Environmental Advisory Board Meeting

Utilizing Trenchless Technologies for Water Main Upgrades at Robins Air Force Base (AFB)

Jonathan Raymer, P.E.
Tepa EC, Warner Robins, Georgia

August 6, 2009

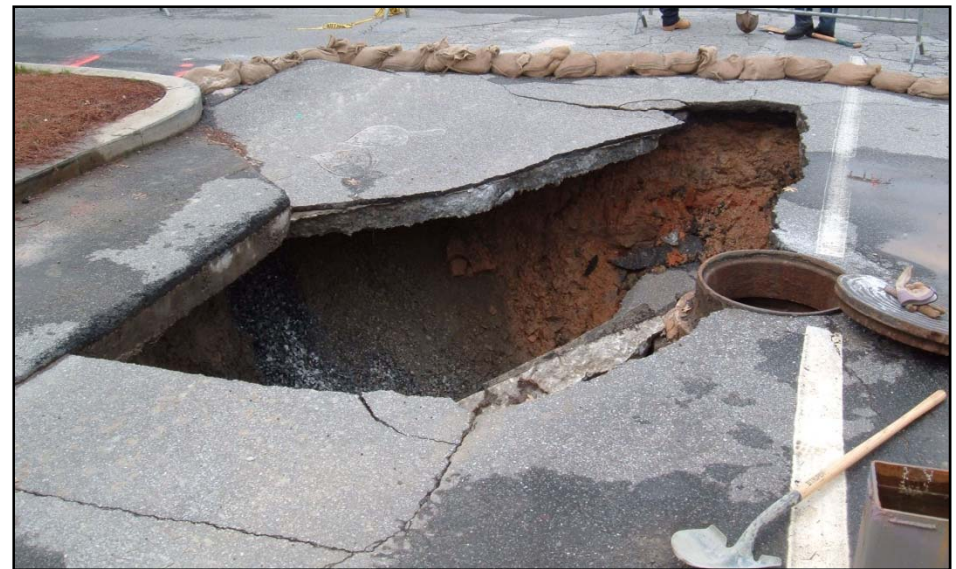
Sinkhole at Georgia Tech – 32 feet deep
Caused by rainwater leaking into broken sewer pipe

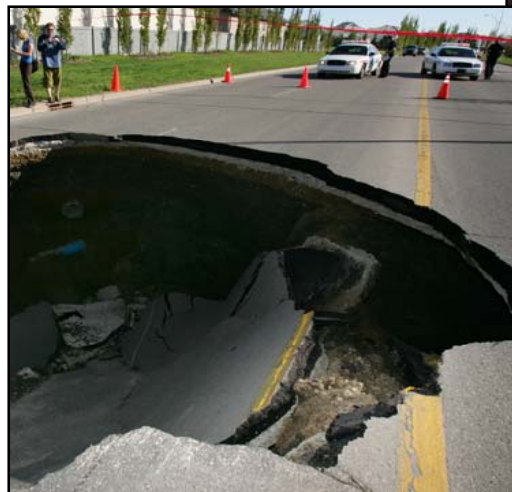
Sinkhole from leaking water line

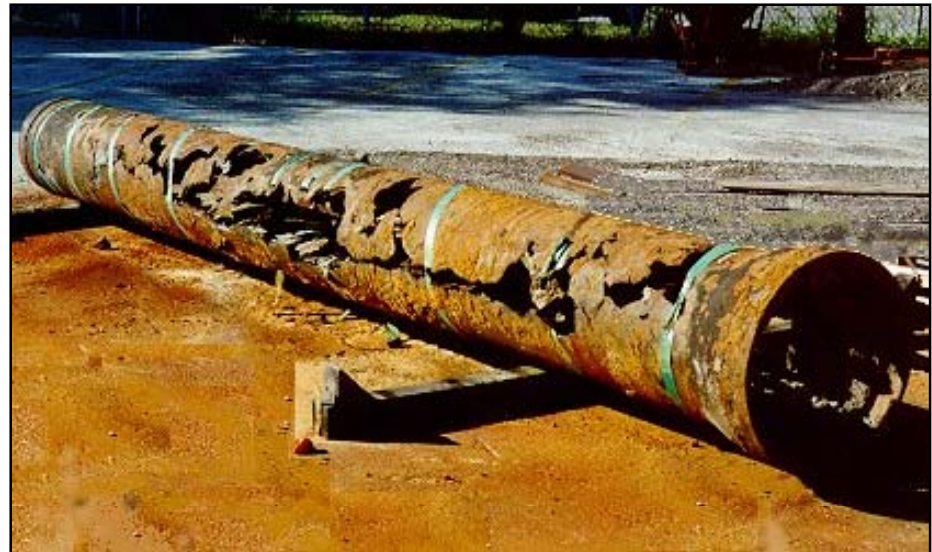
Deteriorated piping allows infiltration overwhelms collection systems and treatment plants

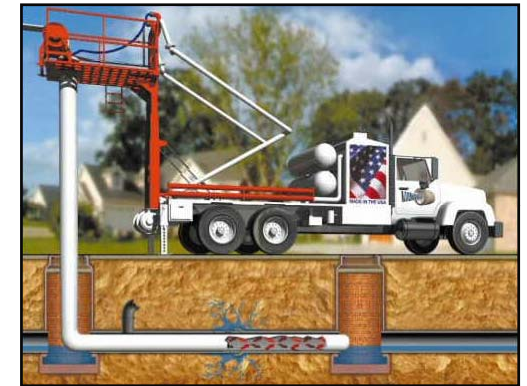
Slip lining utility pipe

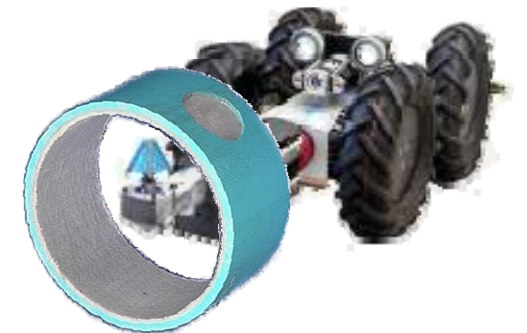
Robotic Cutter

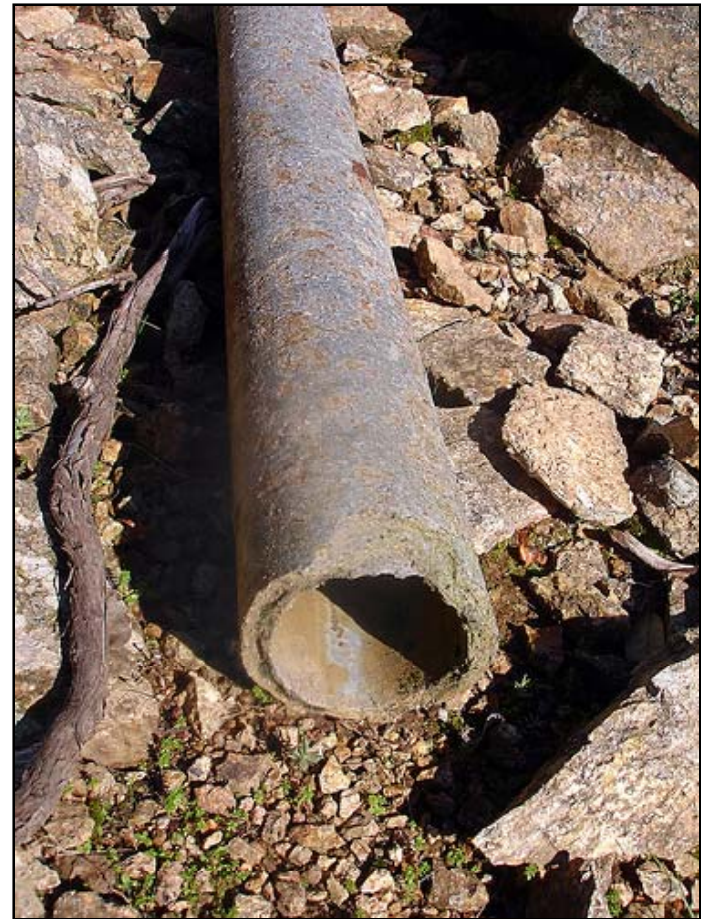
Asbestos cement piping

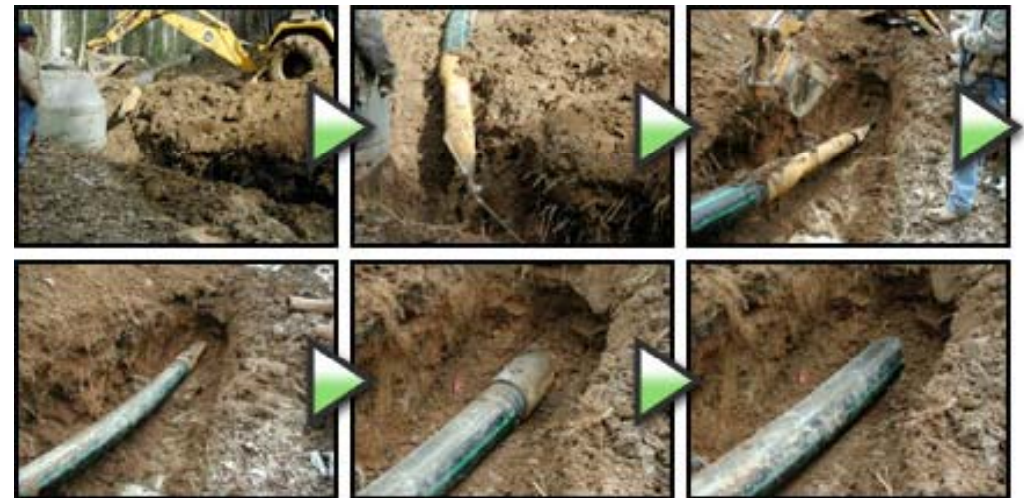
- Breaking existing pipe while simultaneously pulling in the new carrier line
- Usually HDPE but Ductile Iron, Steel, and PVC can be used
- Pipe pulling distances
 - 0 - 350' (very common)
 - > 1,000' are rare but done
- Pipe diameter same size or one size larger common
- Surface cover needed

Pipe bursting steps

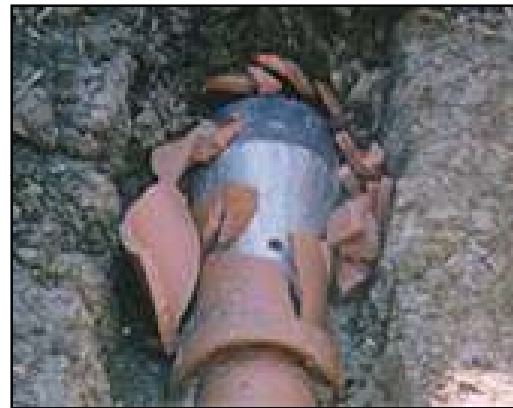
Vitrified clay pipe

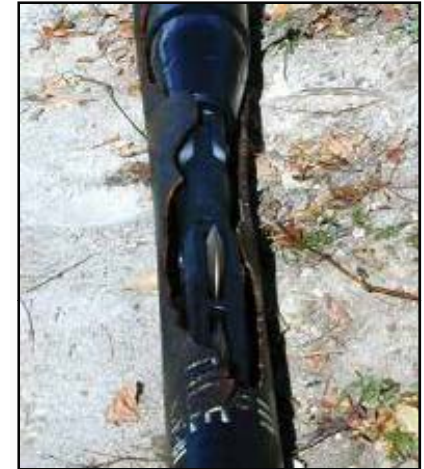
Ductile iron pipe

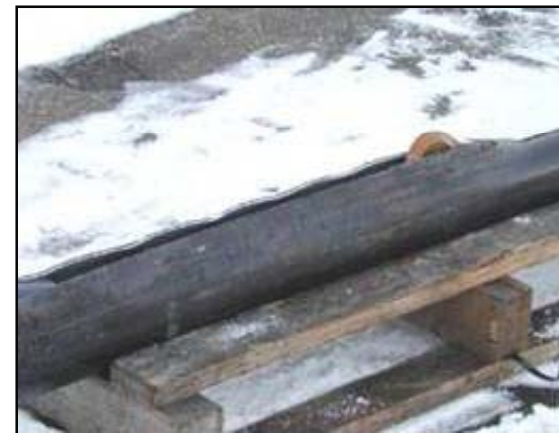
Cast iron pipe

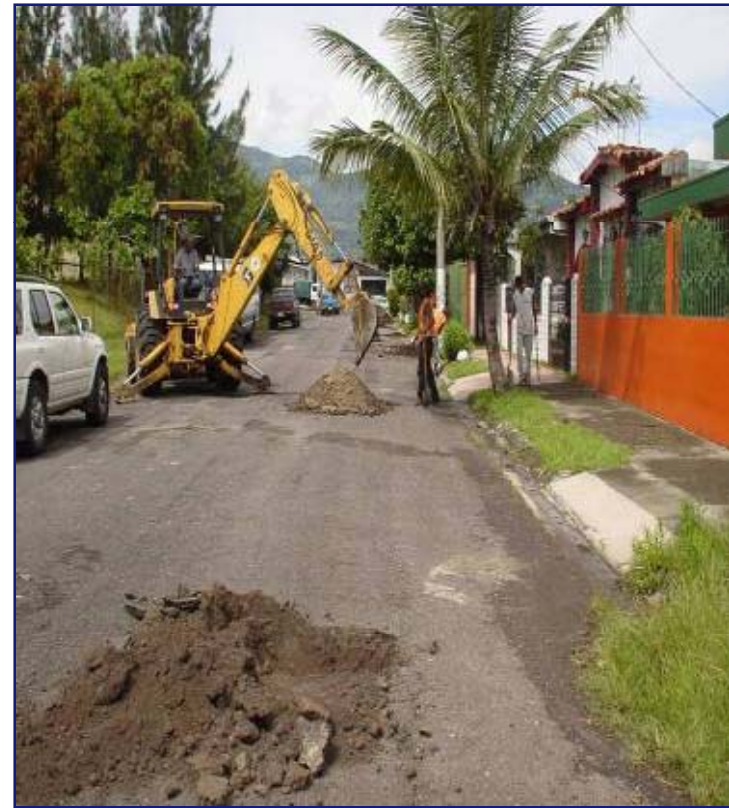
Typical excavation for pipe bursting

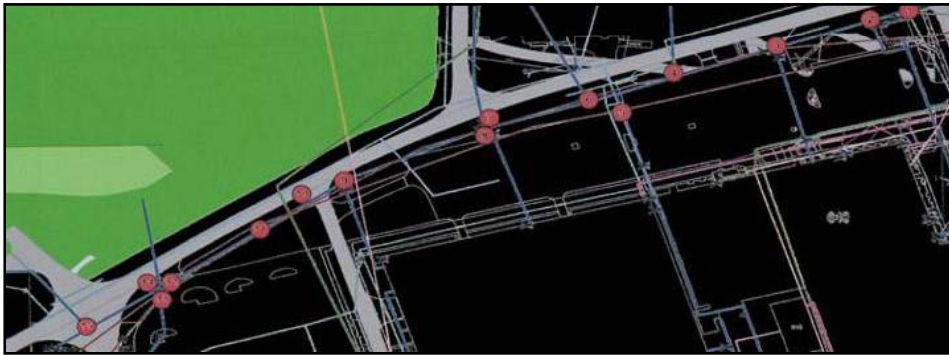
Location of water main replacement along Page Road

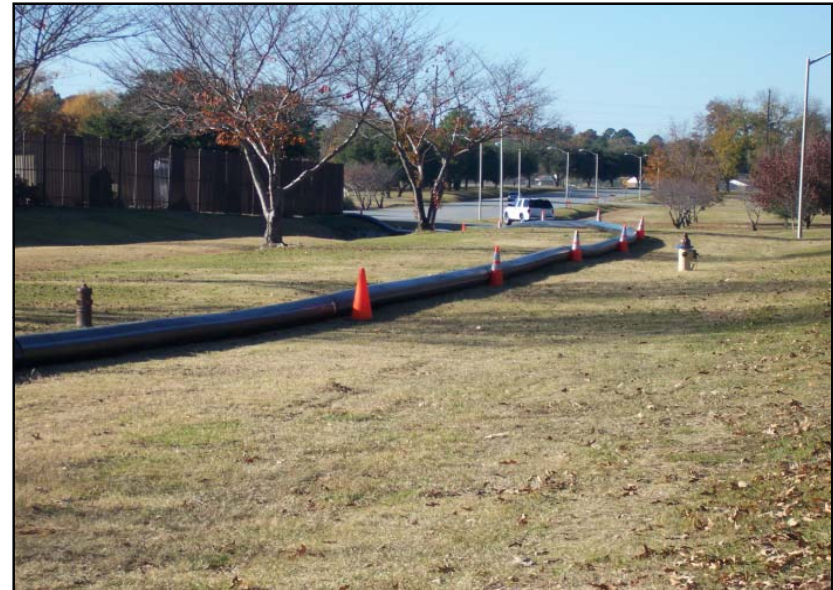
HDPE pipe fused on-site

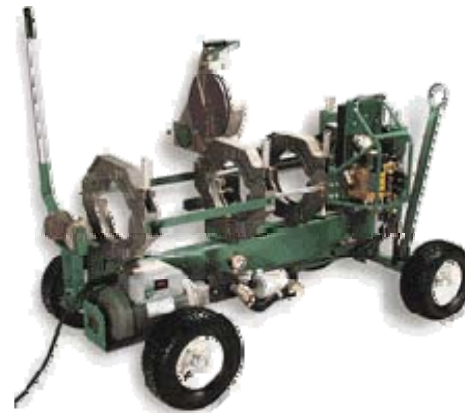
HDPE pipe welding/fusing machine

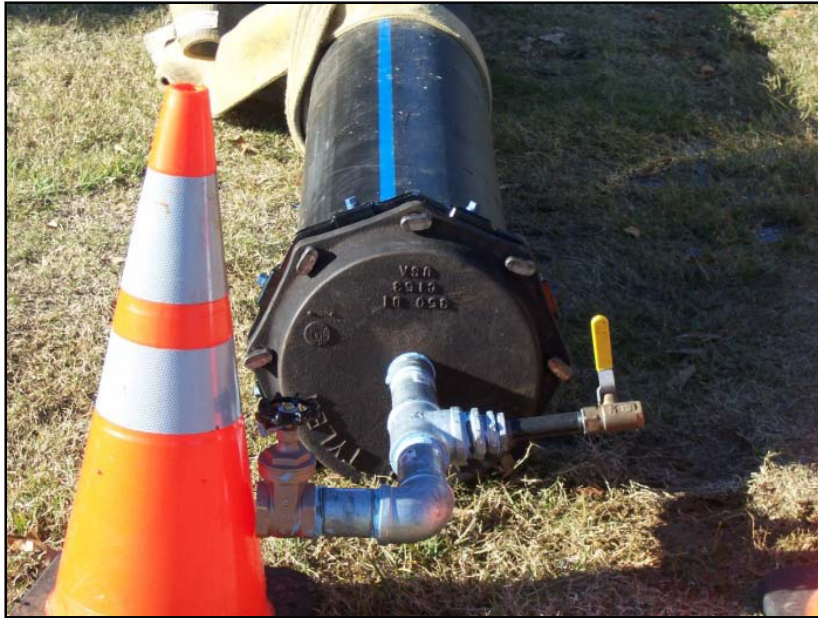
Valve assembly for disinfection of HDPE pipe

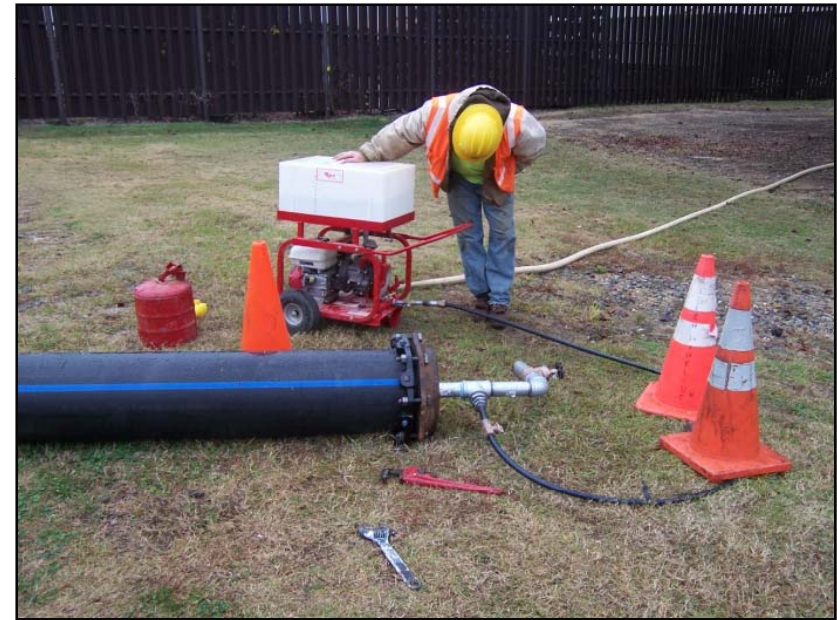
Injection of disinfection fluid into HDPE pipe

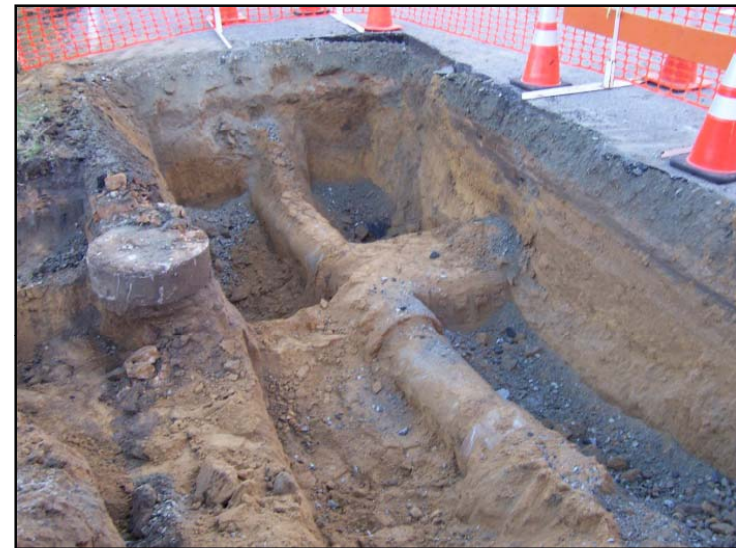
Exposing existing water pipe

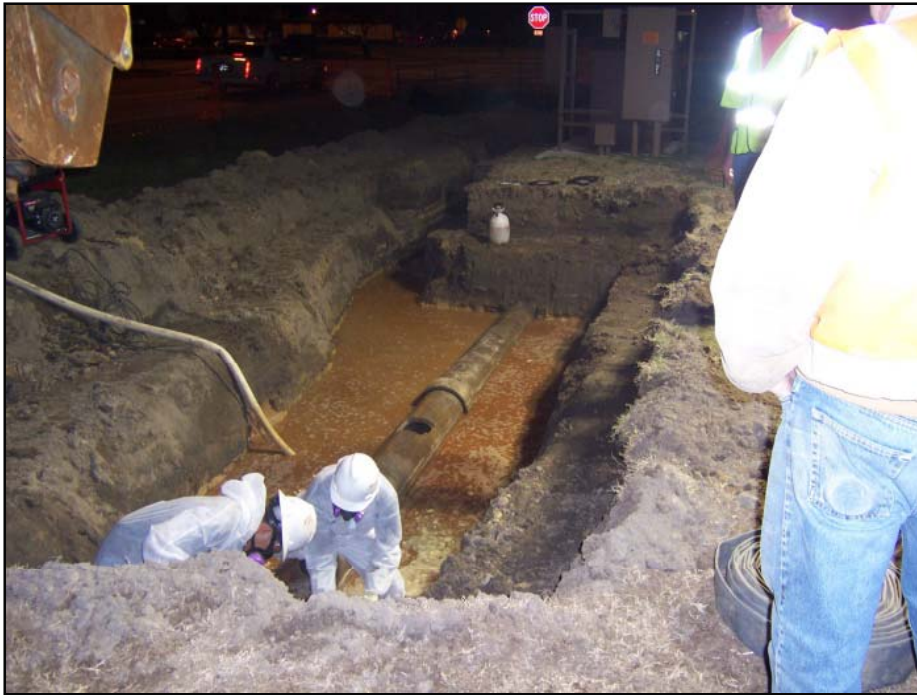
Removing existing pipe at access pit

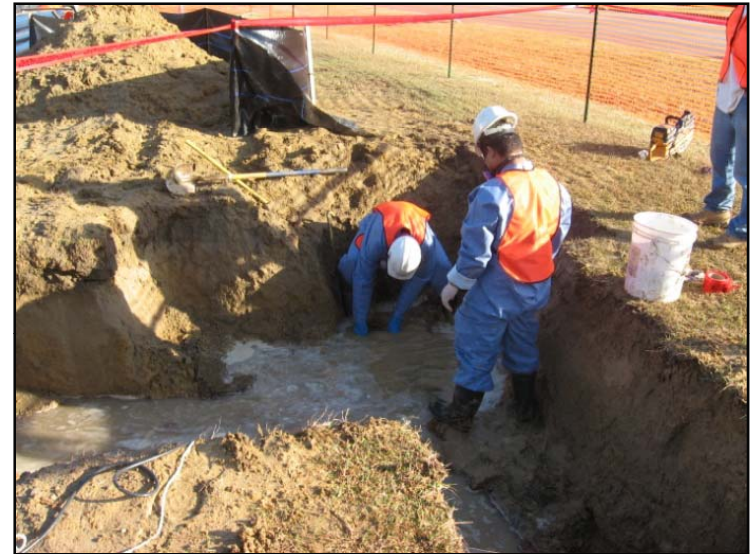
Pipe bursting access pit

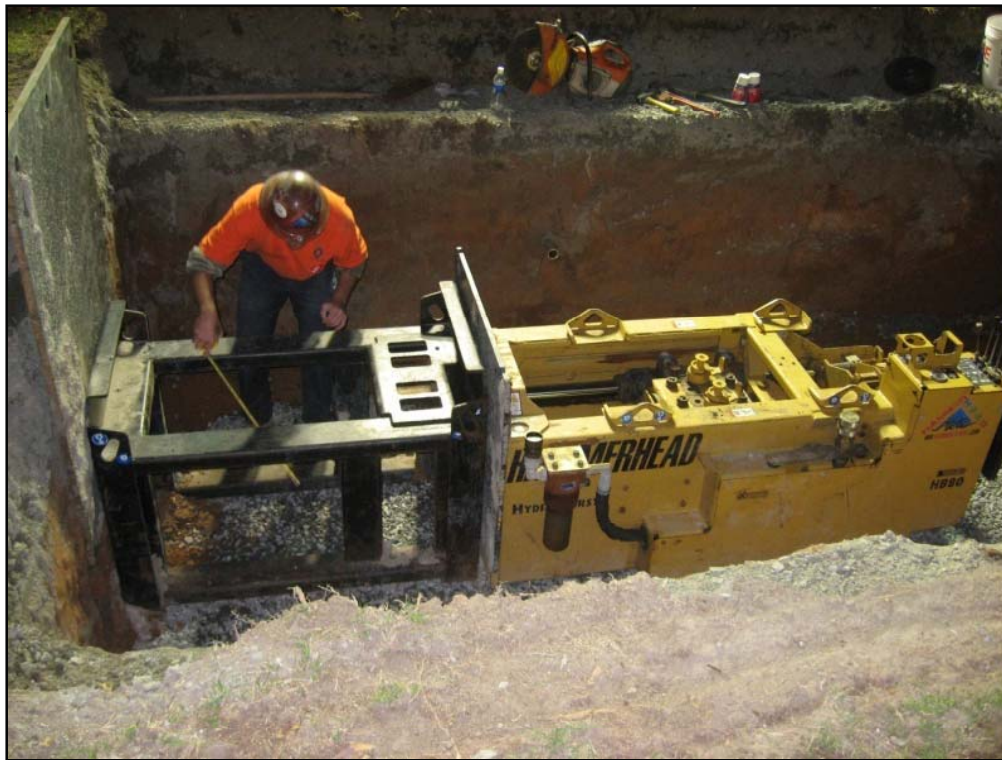
Pipe bursting pulling equipment

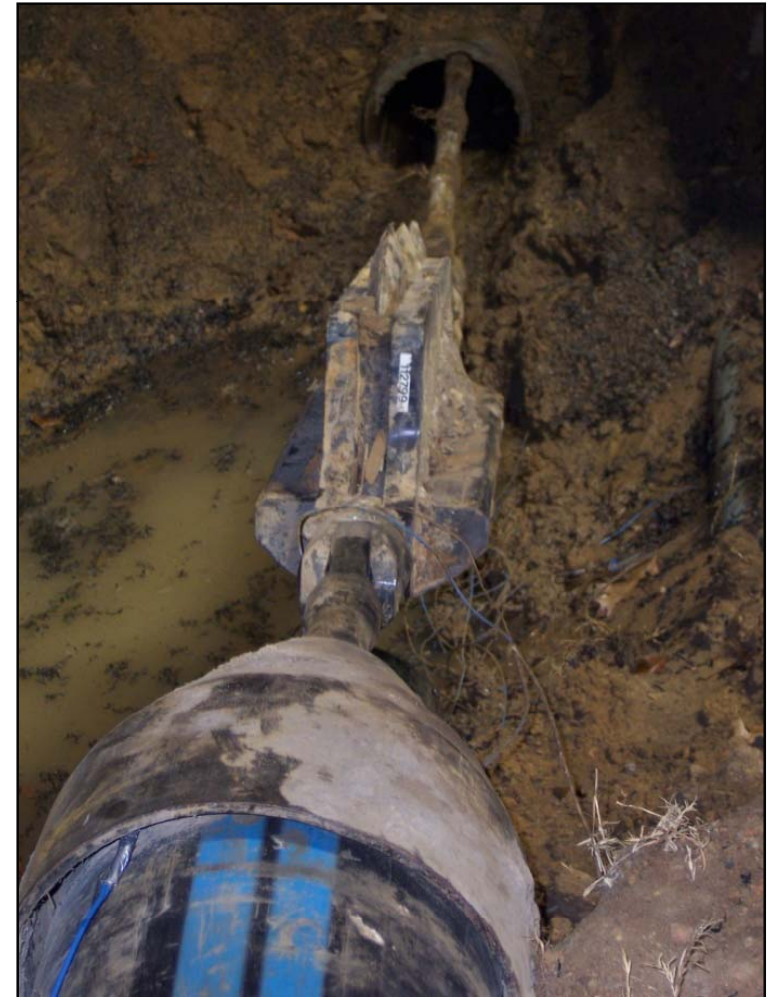
New HDPE pipe being pulled in place

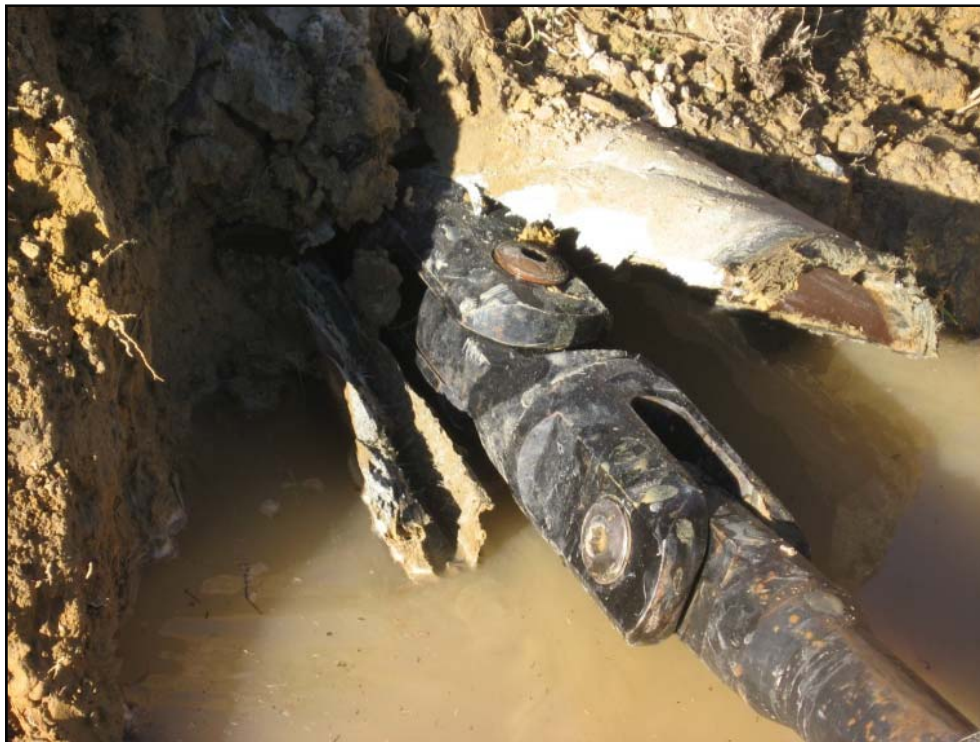
Splitter entering existing pipe

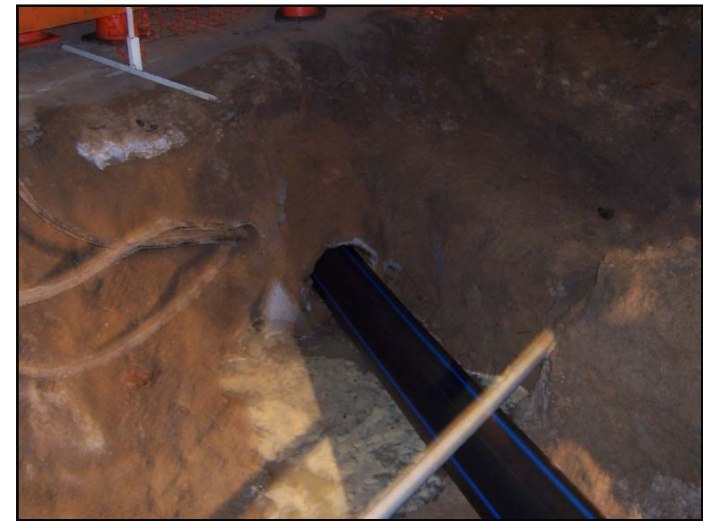
Installation of new of HDPE pipe

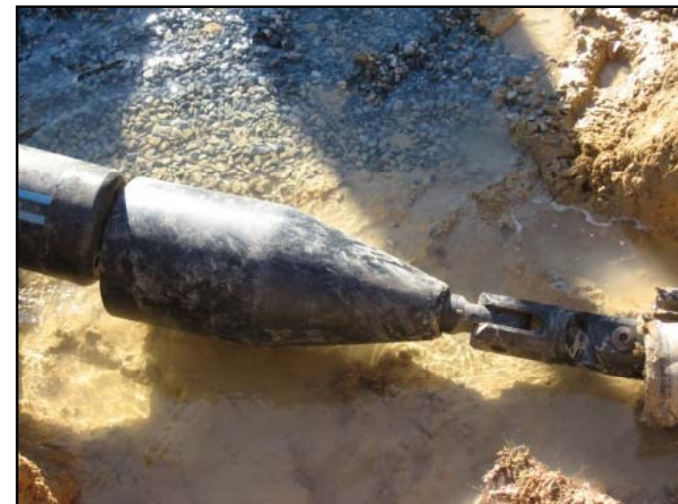
Expander head entering existing pipe

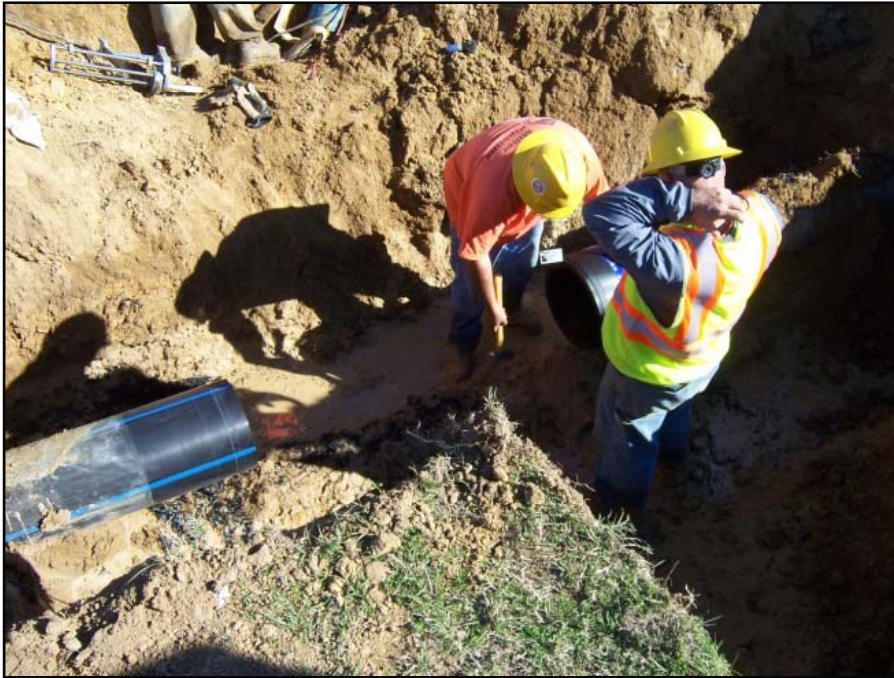
Installing new valve assembly

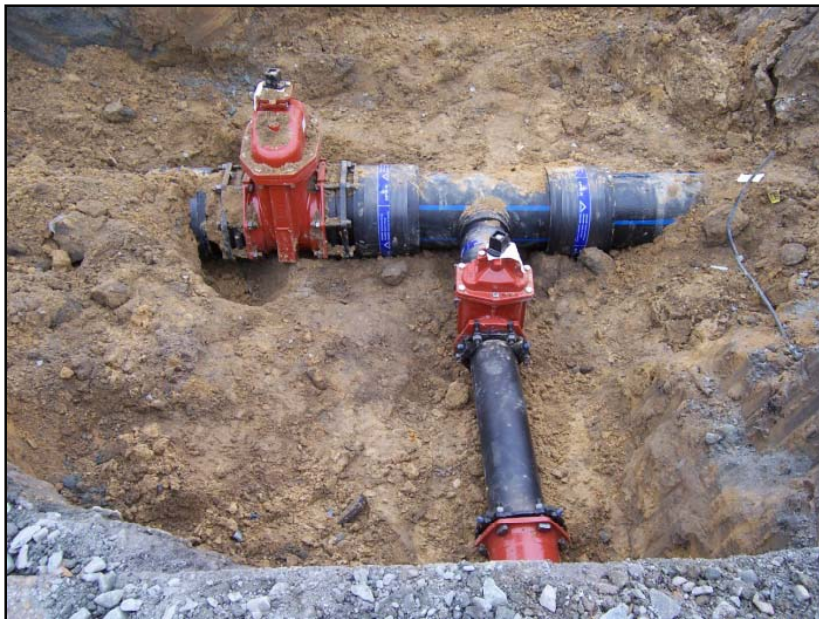
New pipe and valve installed

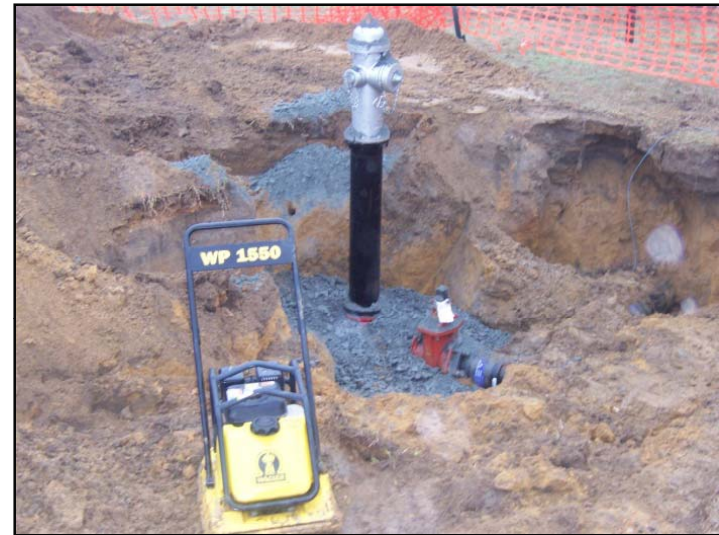
New fire hydrant installed

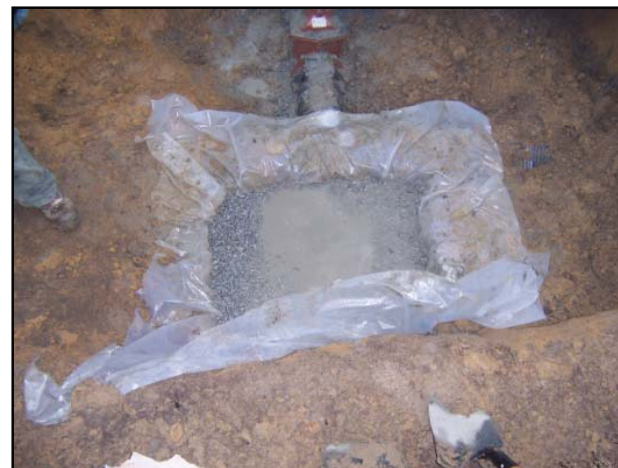
Thrust block

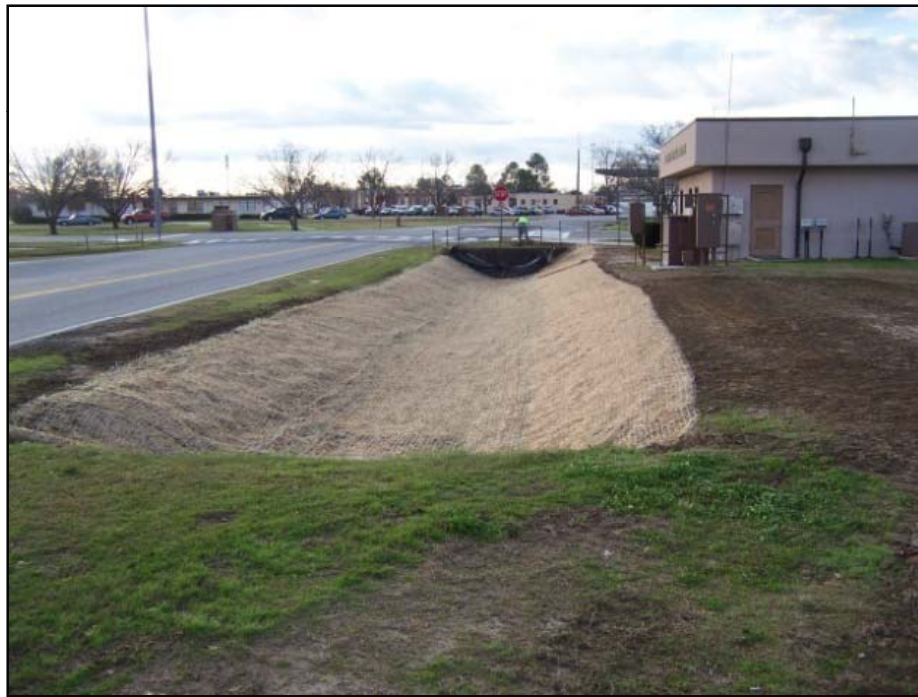
Erosion control matting
