Environmental Advisory Board Meeting

**Robins Air Force Base
February 13, 2020**

Update on Progress at Select Restoration Sites

SWMU 62 (OT037) Update on Progress

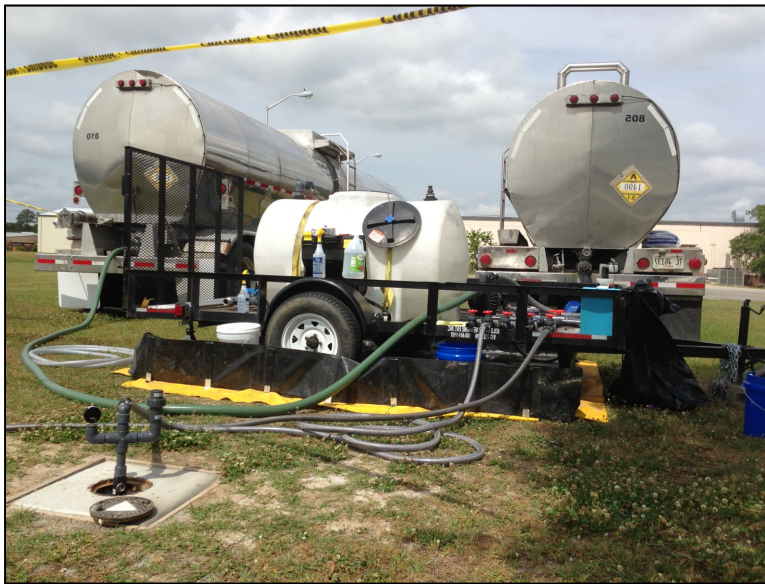
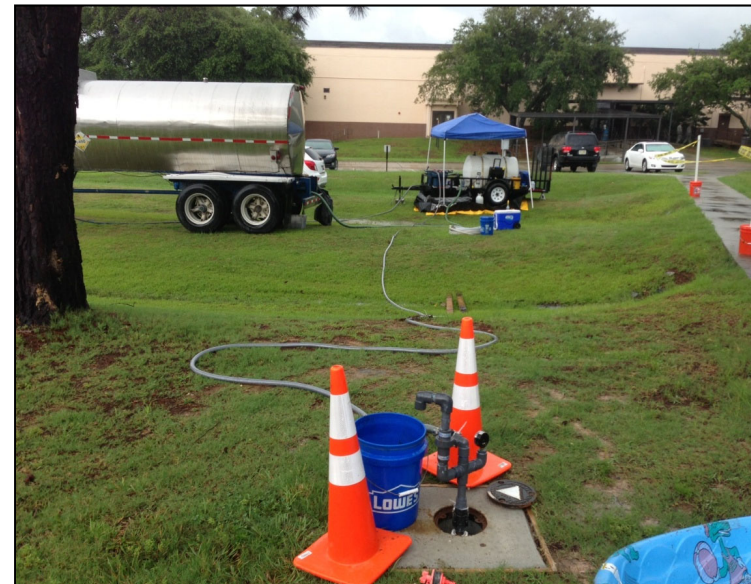
Oxidant Injection

- **New remedy implemented in 2013**
 - Groundwater extraction wells shut down
 - In situ chemical oxidation (ISCO) using potassium permanganate (KMnO_4)
 - Injected 240,000 gallons of 3 percent KMnO_4 in 22 injection wells in May and June

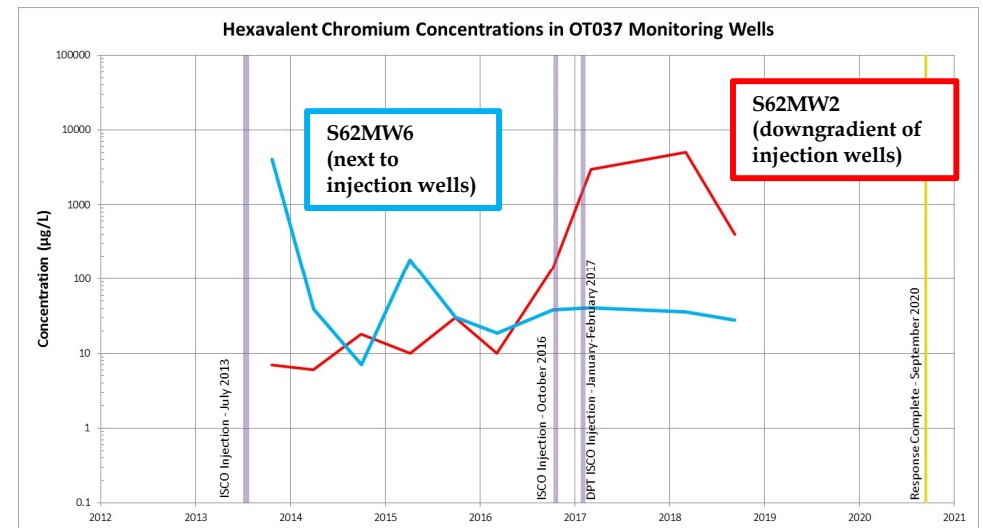
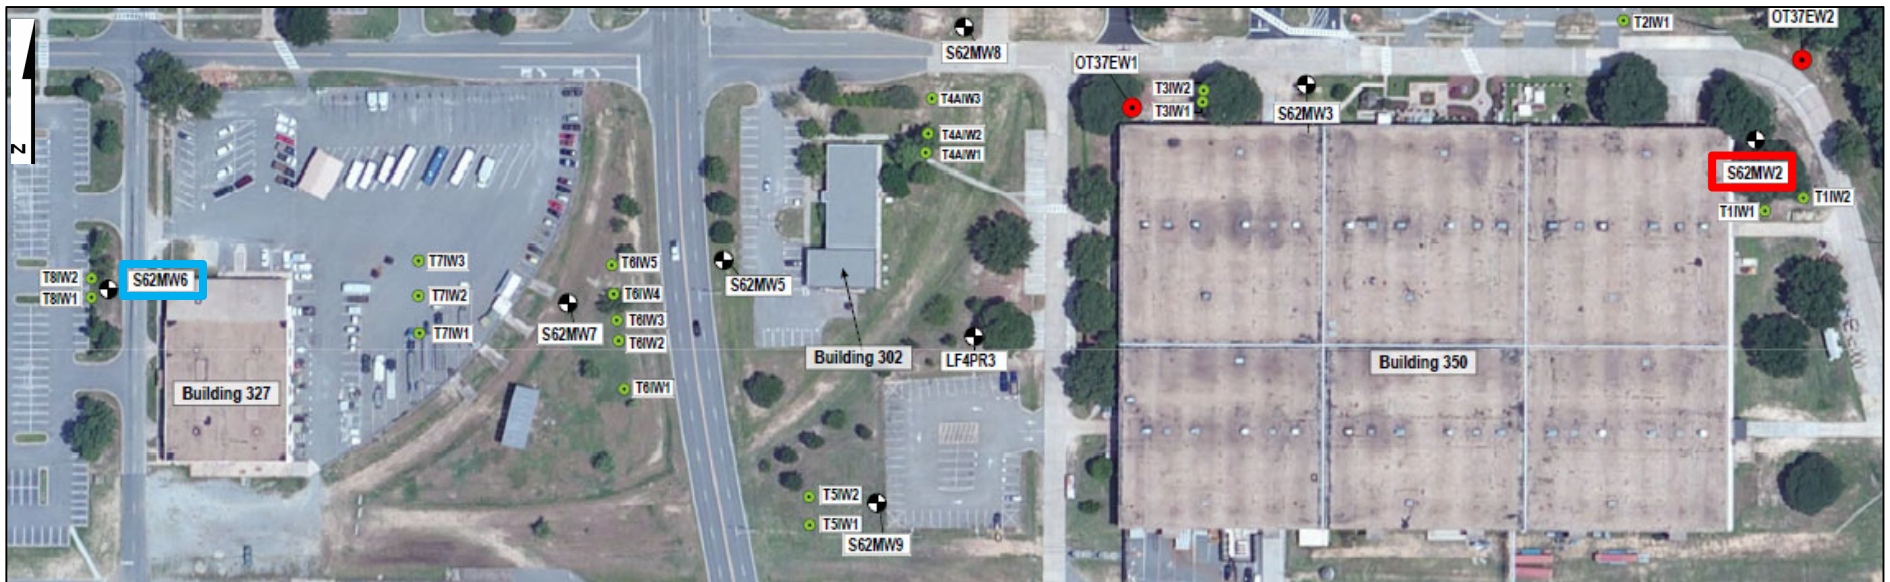
- ISCO can mobilize naturally present metals due to redox changes
- Metals concentrations increased after the first injection and then gradually decreased

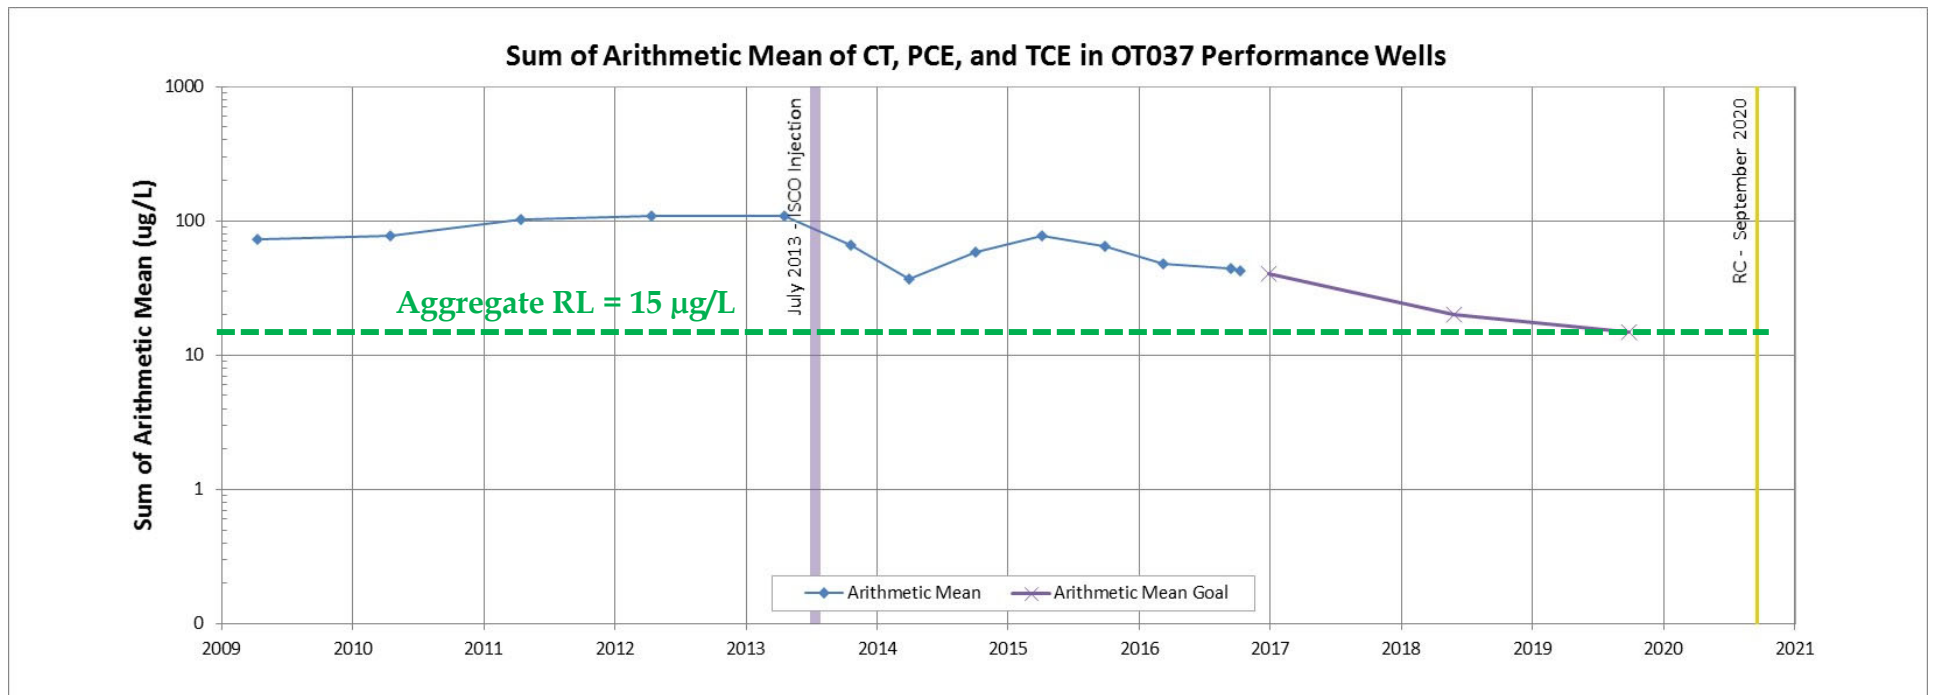
■ Aggregate trends

*Data from 17 wells used to assess remediation progress

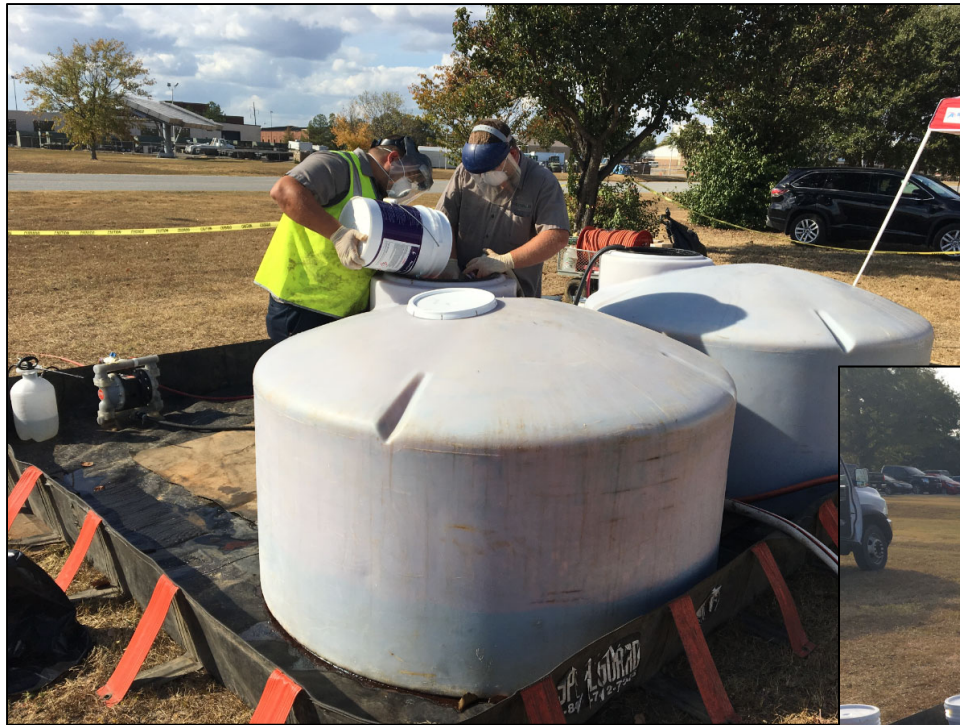
Addition of dry KMnO_4 to prepare 1.5% oxidant solution

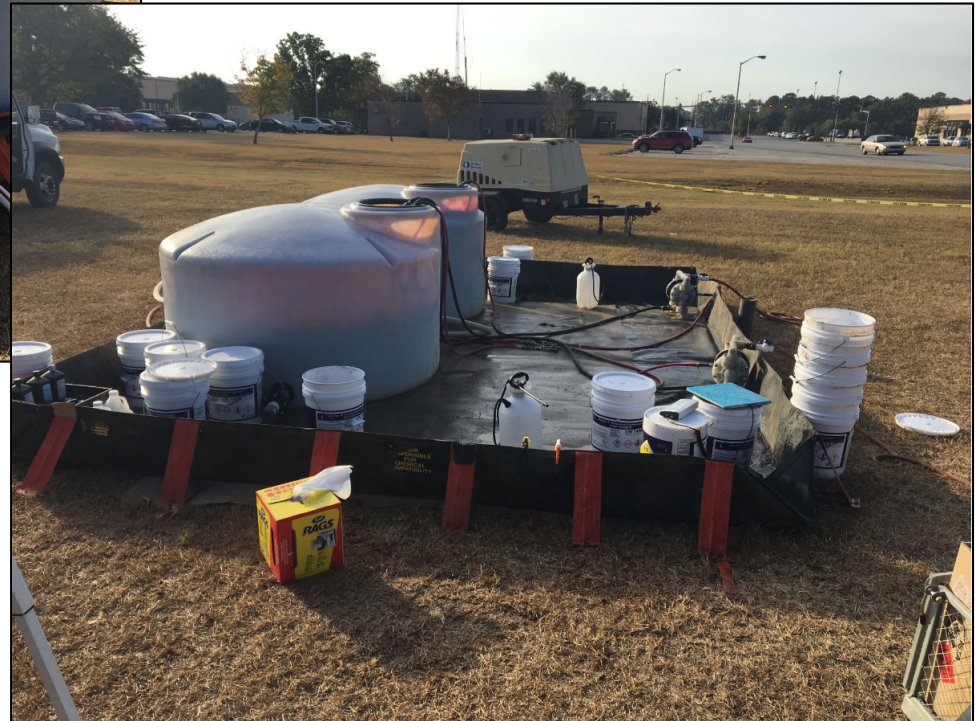
**1.5% oxidant solution
secondary containment
during injection**

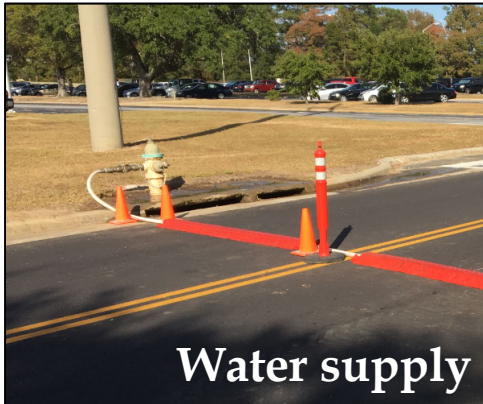
Water supply

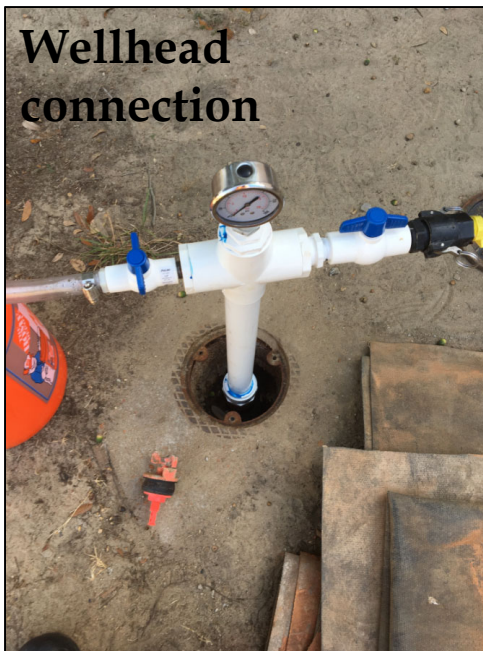
Wellhead connection

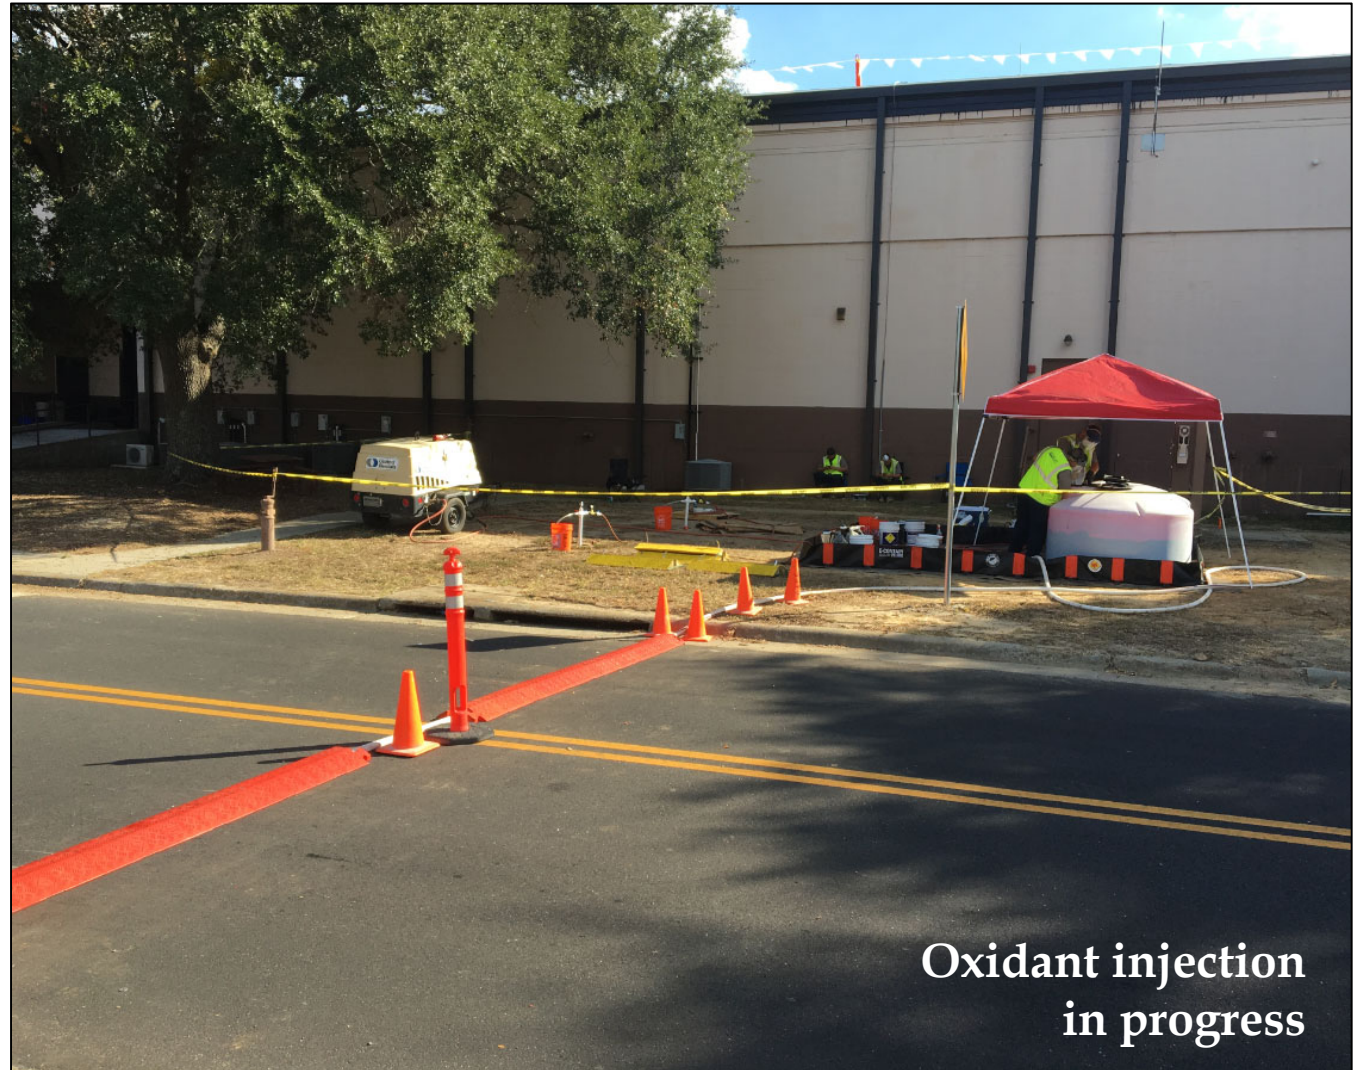
**Oxidant injection
in progress**

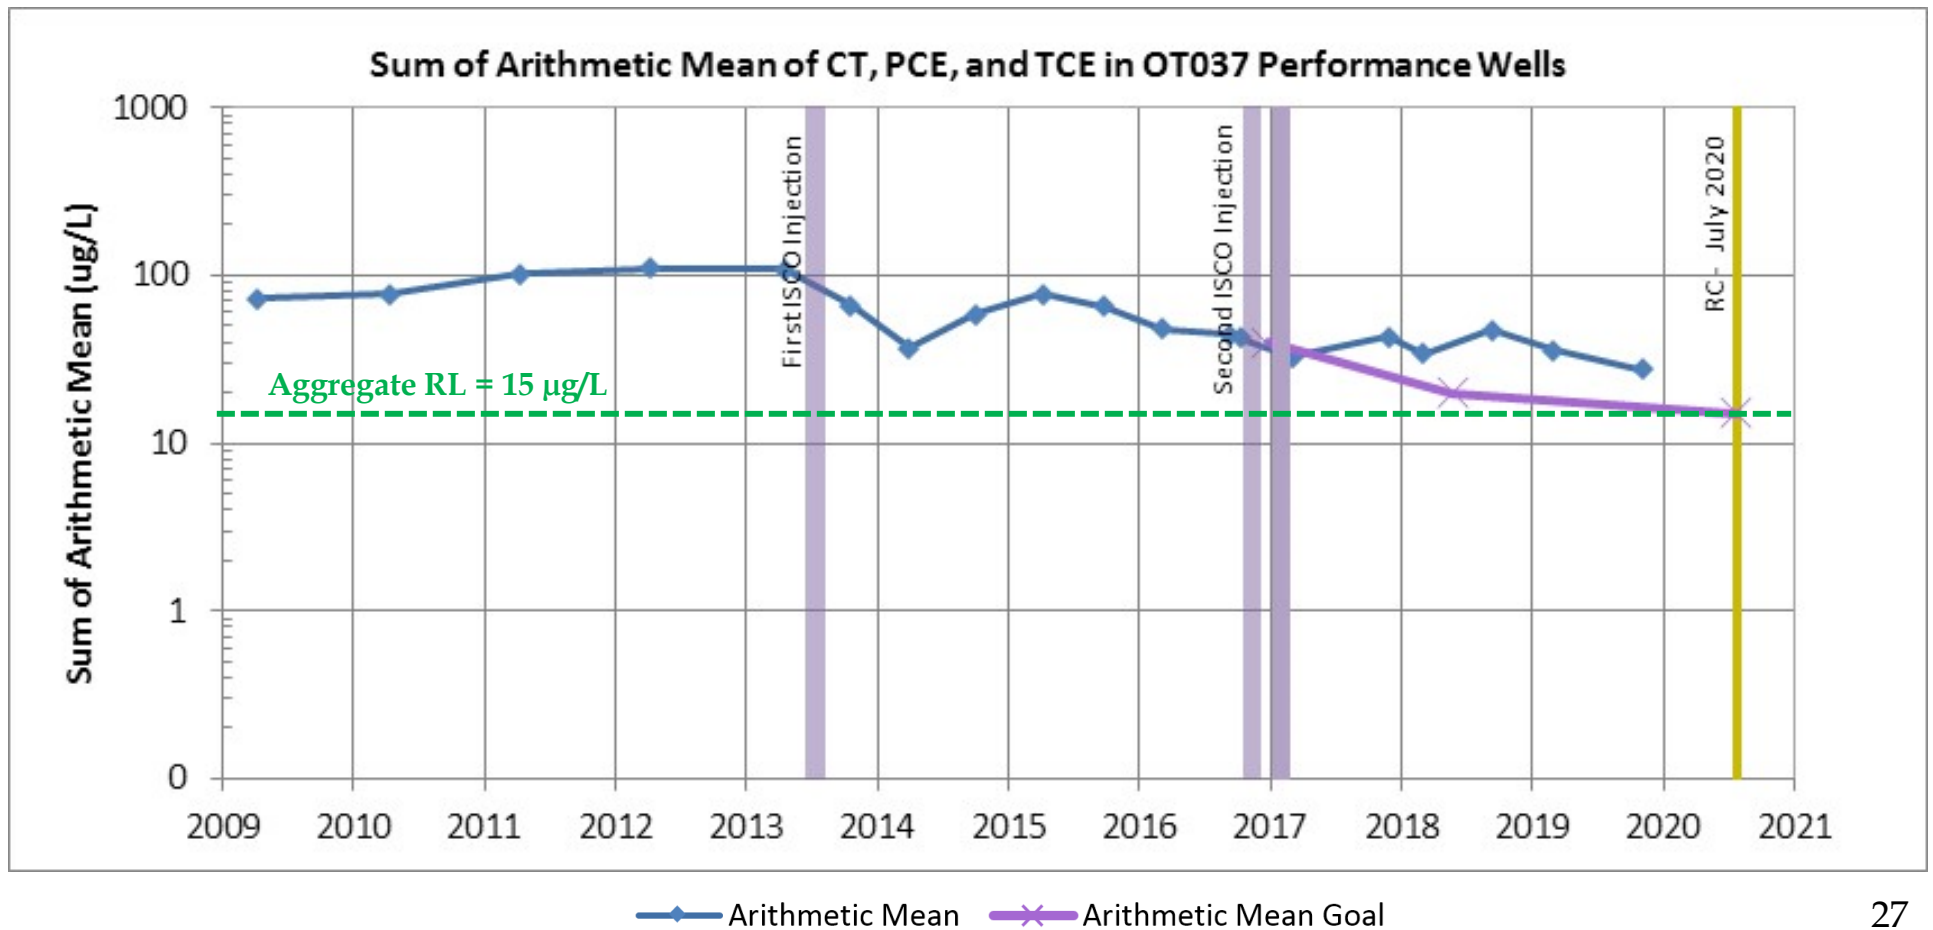
■ Aggregate trends

*Data from 17 wells used to assess remediation progress

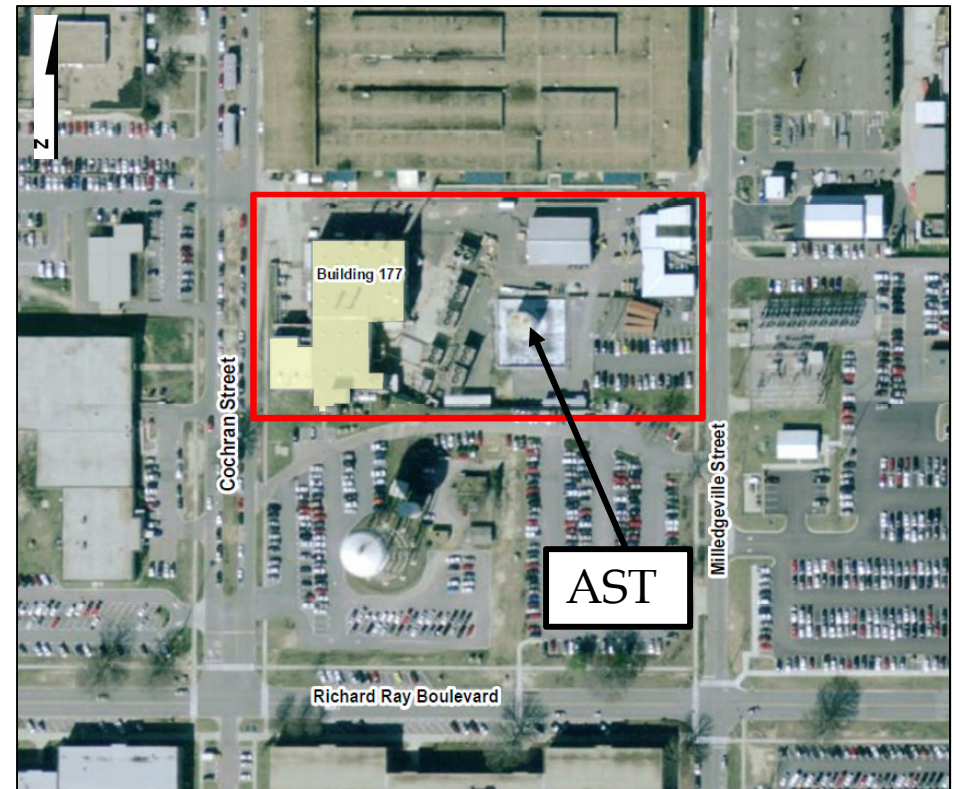
- SWMU 47 is located east of Building 177 in vicinity of 250,000-gallon aboveground storage tank (AST) that contains No. 2 diesel fuel
- Building 177 is a steam plant that supports Greater Base Industrial Area (GBIA) and other areas

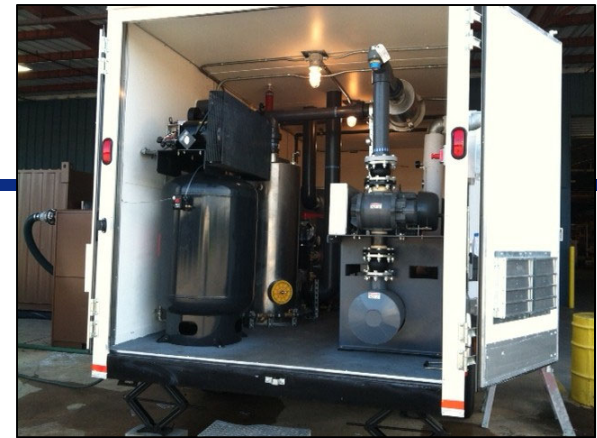
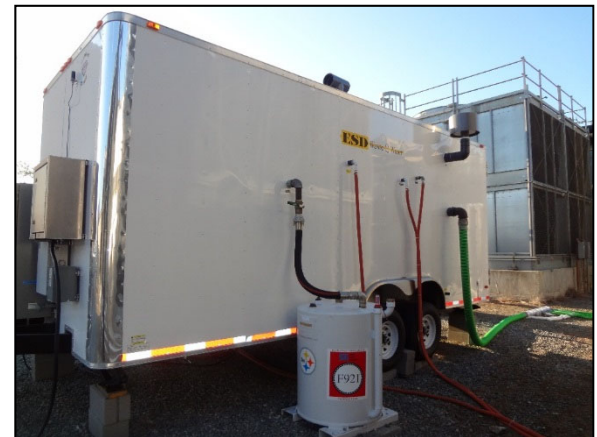
Remediation Trailer (↑) and LNAPL Collection Tank (↓)

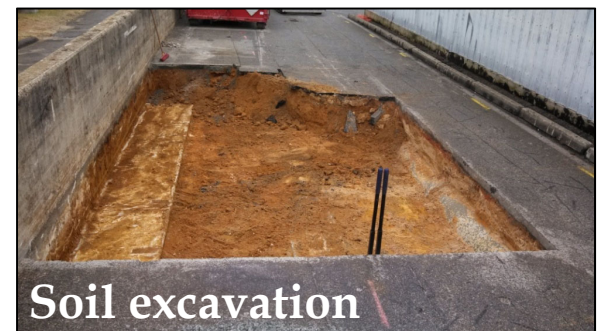
Soil excavation

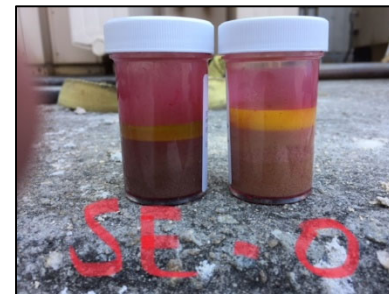
Positive result

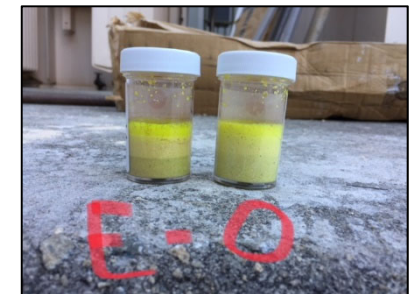
Negative result

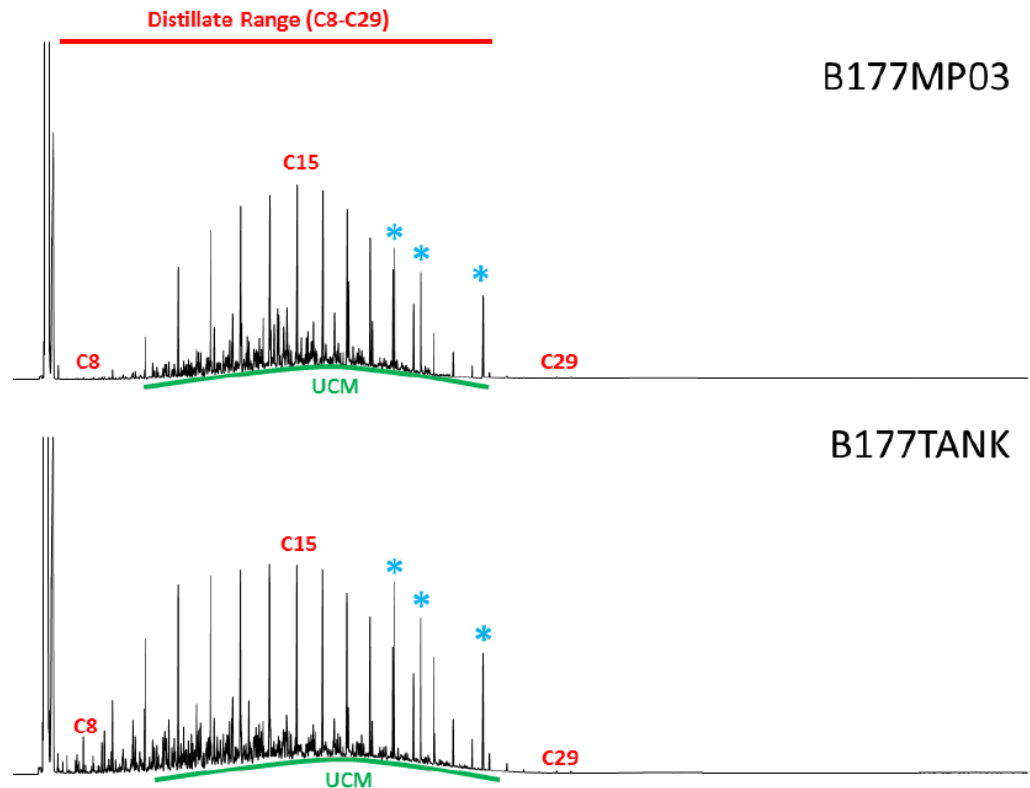
- Both samples were relatively unweathered diesel fuel (Figure 1)
- However, sulfur content for LNAPL is consistent with high sulfur diesel fuel while sample from AST is consistent with an ultra-low sulfur diesel fuel (Figure 2)
- Therefore, LNAPL in site monitoring wells at SWMU 47 is not resulting from an ongoing leak from AST

Figure 1. GC/FID fingerprints of the study samples:

a) B177MP03

b) B177TANK

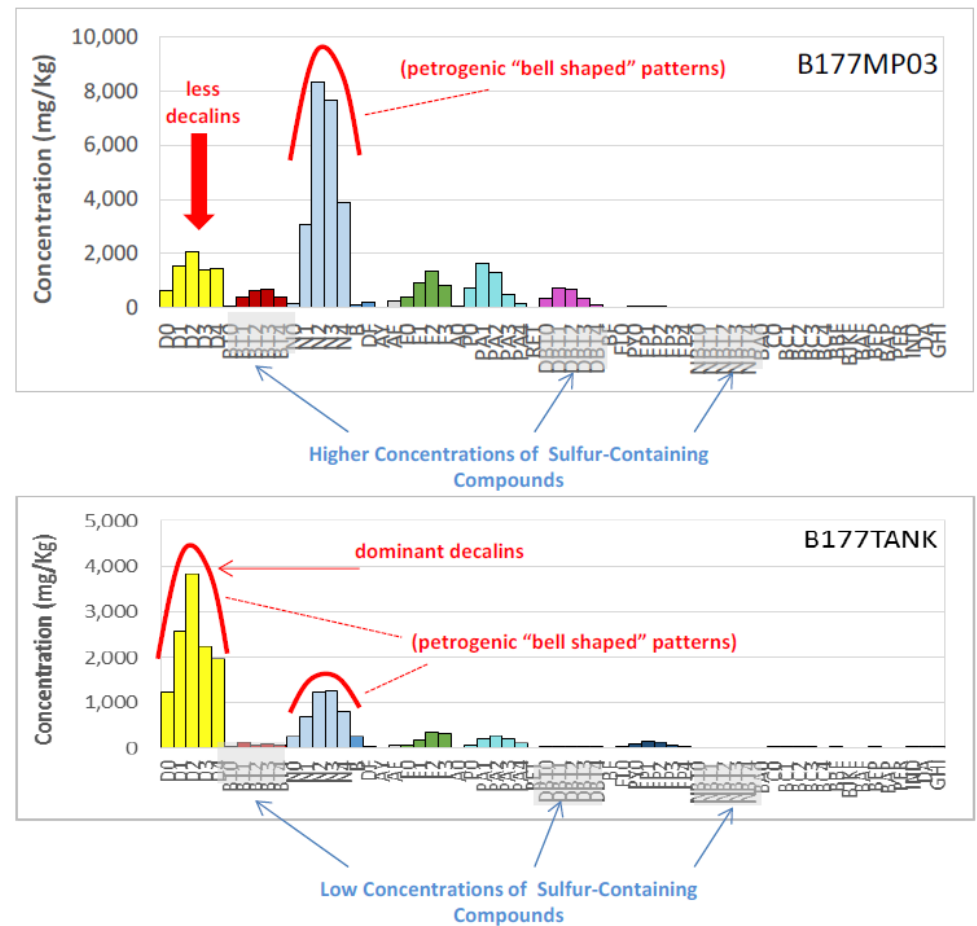
- Both samples were relatively unweathered diesel fuel (Figure 1)
- However, sulfur content for LNAPL is consistent with high sulfur diesel fuel while sample from AST is consistent with an ultra-low sulfur diesel fuel (Figure 2)
- Therefore, LNAPL in site monitoring wells at SWMU 47 is not resulting from an ongoing leak from AST

Figure 2. Compositional Analysis of Field Samples (PAH histograms)
a) B177MP03
b) B177TANK

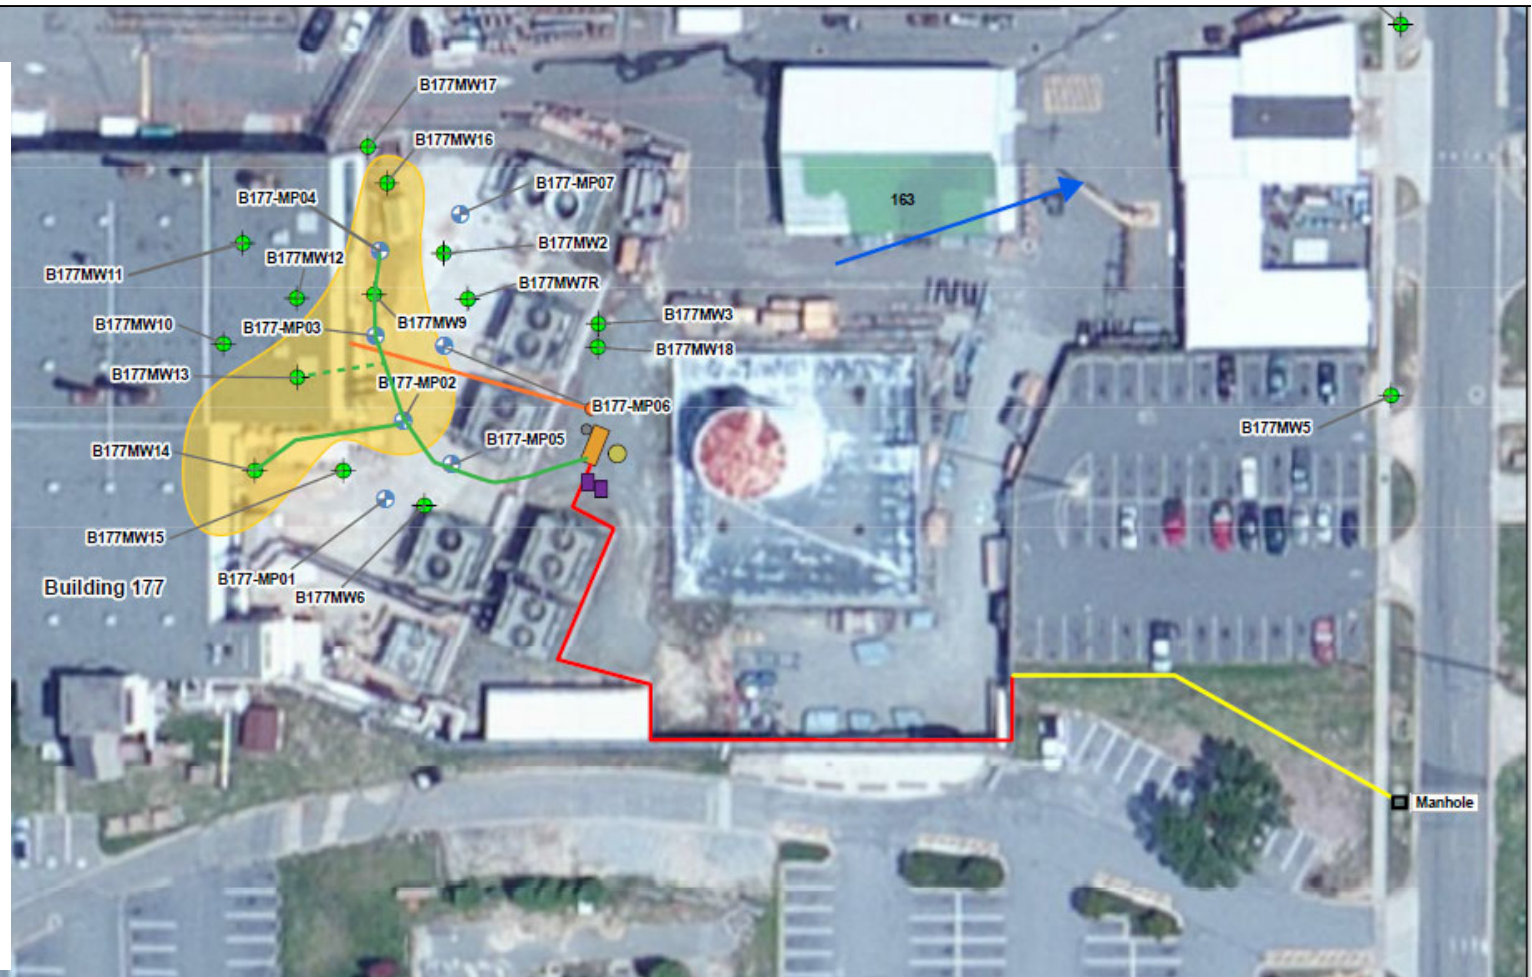
Alternative 1

- Use existing infrastructure and new monitoring wells to conduct surfactant flushing and MPE
- Six surfactant events over four years
- Remediation timeframe estimated at 5 years
- Total cost = \$1,250,000

- Expected to achieve corrective action objectives (CAOs) within 5 years
- Easiest to implement because infrastructure is currently in place
- Most expensive alternative because it would require regular operations and maintenance (O&M) for 5 years

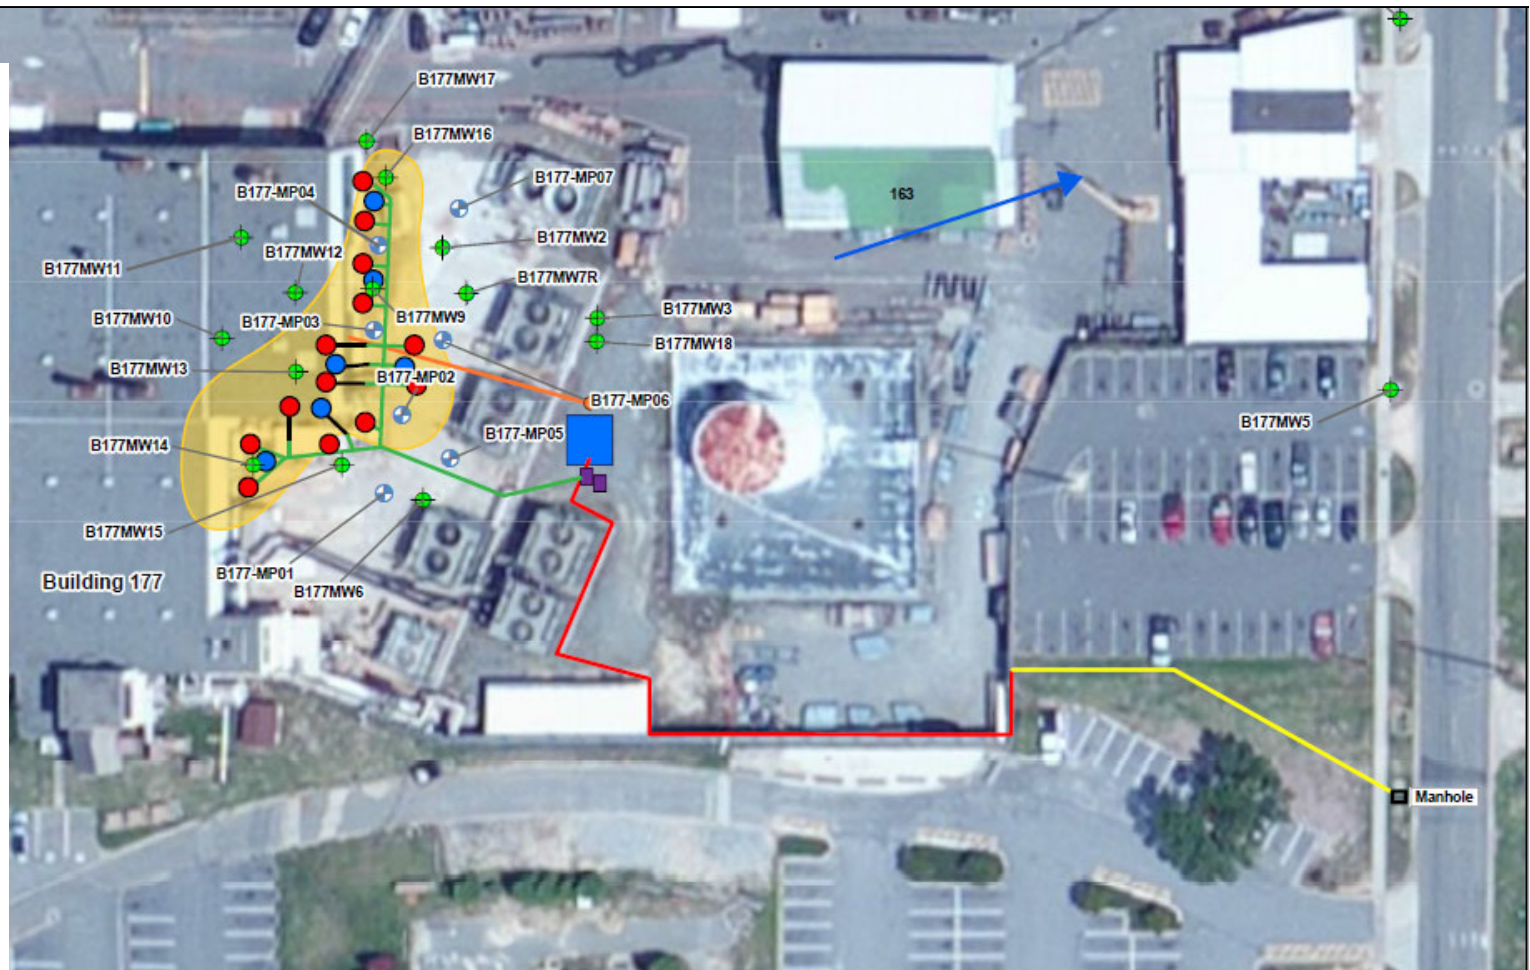
Alternative 2

- Install AS/SVE system to reduce LNAPL and volatile organic compound (VOC) concentrations
- Angled AS and SVE wells would be used to access underneath the building
- New remediation equipment
- Remediation timeframe estimated at 2 years
- Total cost = \$1,000,000

- Expected to be most effective option, achieving CAOs in approximately 2 years.
- Only slightly more expensive than Alternative 3 because of limited O&M requirements
- Most challenging to implement due to installation of new AS and SVE wells, conveyance lines, and other associated infrastructure

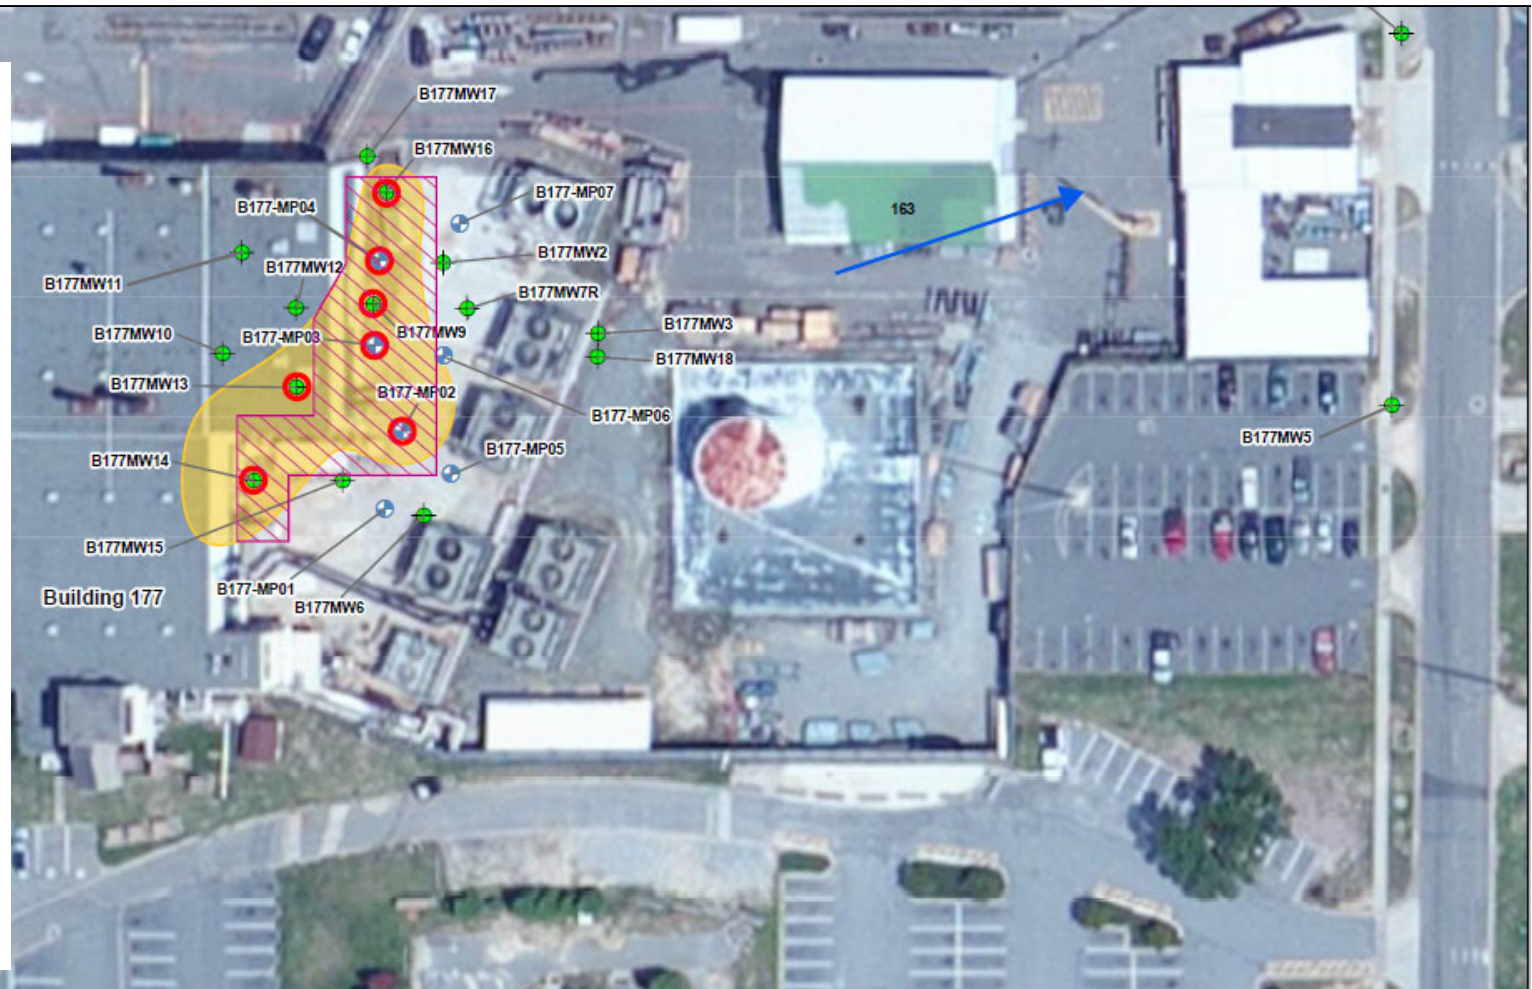
Alternative 3

- Continue HVE to remove LNAPL
- Inject oxygen releasing compound via 40 DPT locations to facilitate enhanced aerobic bioremediation to address residual groundwater impacts
- Remediation timeframe estimated at 8 years
- Total cost = \$900,000

- Most flexible and least expensive alternative
- Expected to take approximately 8 years to achieve CAOs

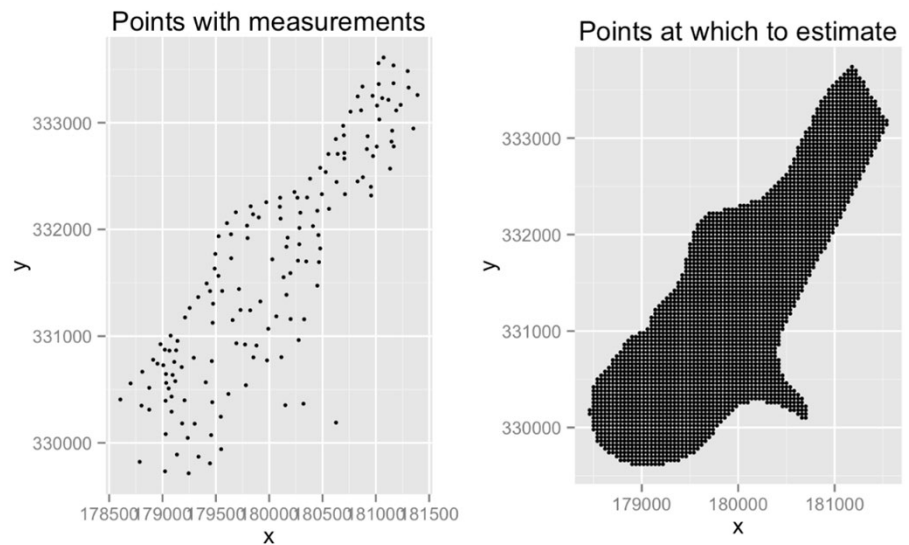
- **Variography**
 - Process of characterizing and modeling spatial continuity (variation) in a data set
- **Gridding (interpolation)**
 - Process of generating a grid of predicted data from a measured data set using two-dimensional (spatial) interpolation methods

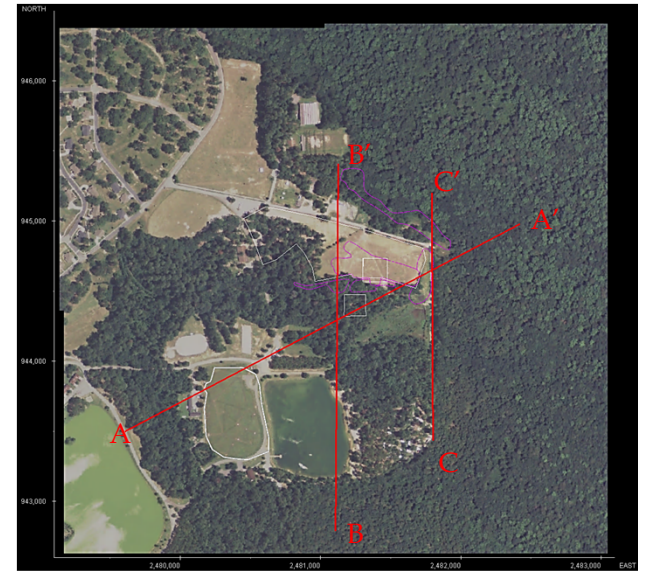
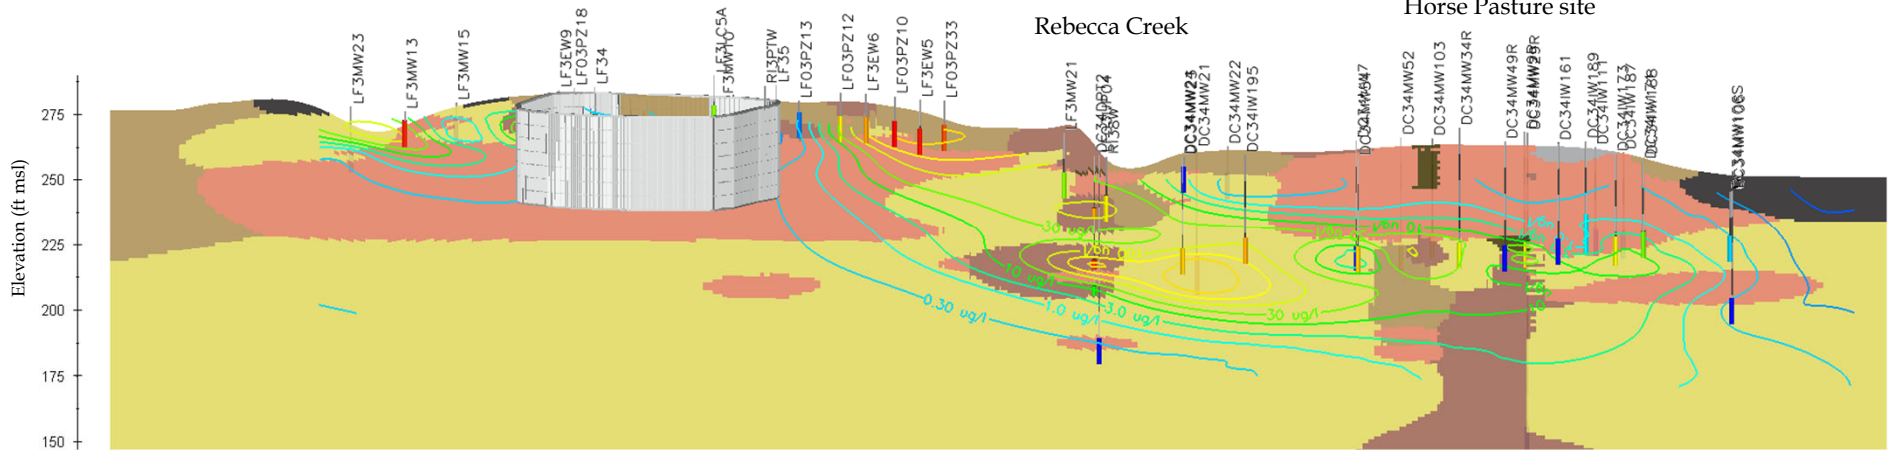
Chlorobenzene

LF003 slurry wall

Rebecca Creek

Horse Pasture site
